**BLUE MARSH DAM  
AND**

**RESERVOIR**

CONDITION REPORT.

DAM, OUTLET WORKS, SPILLWAY  
BERNVILLE PROTECTIVE WORKS.  
PERIODIC INSPECTION REPORT

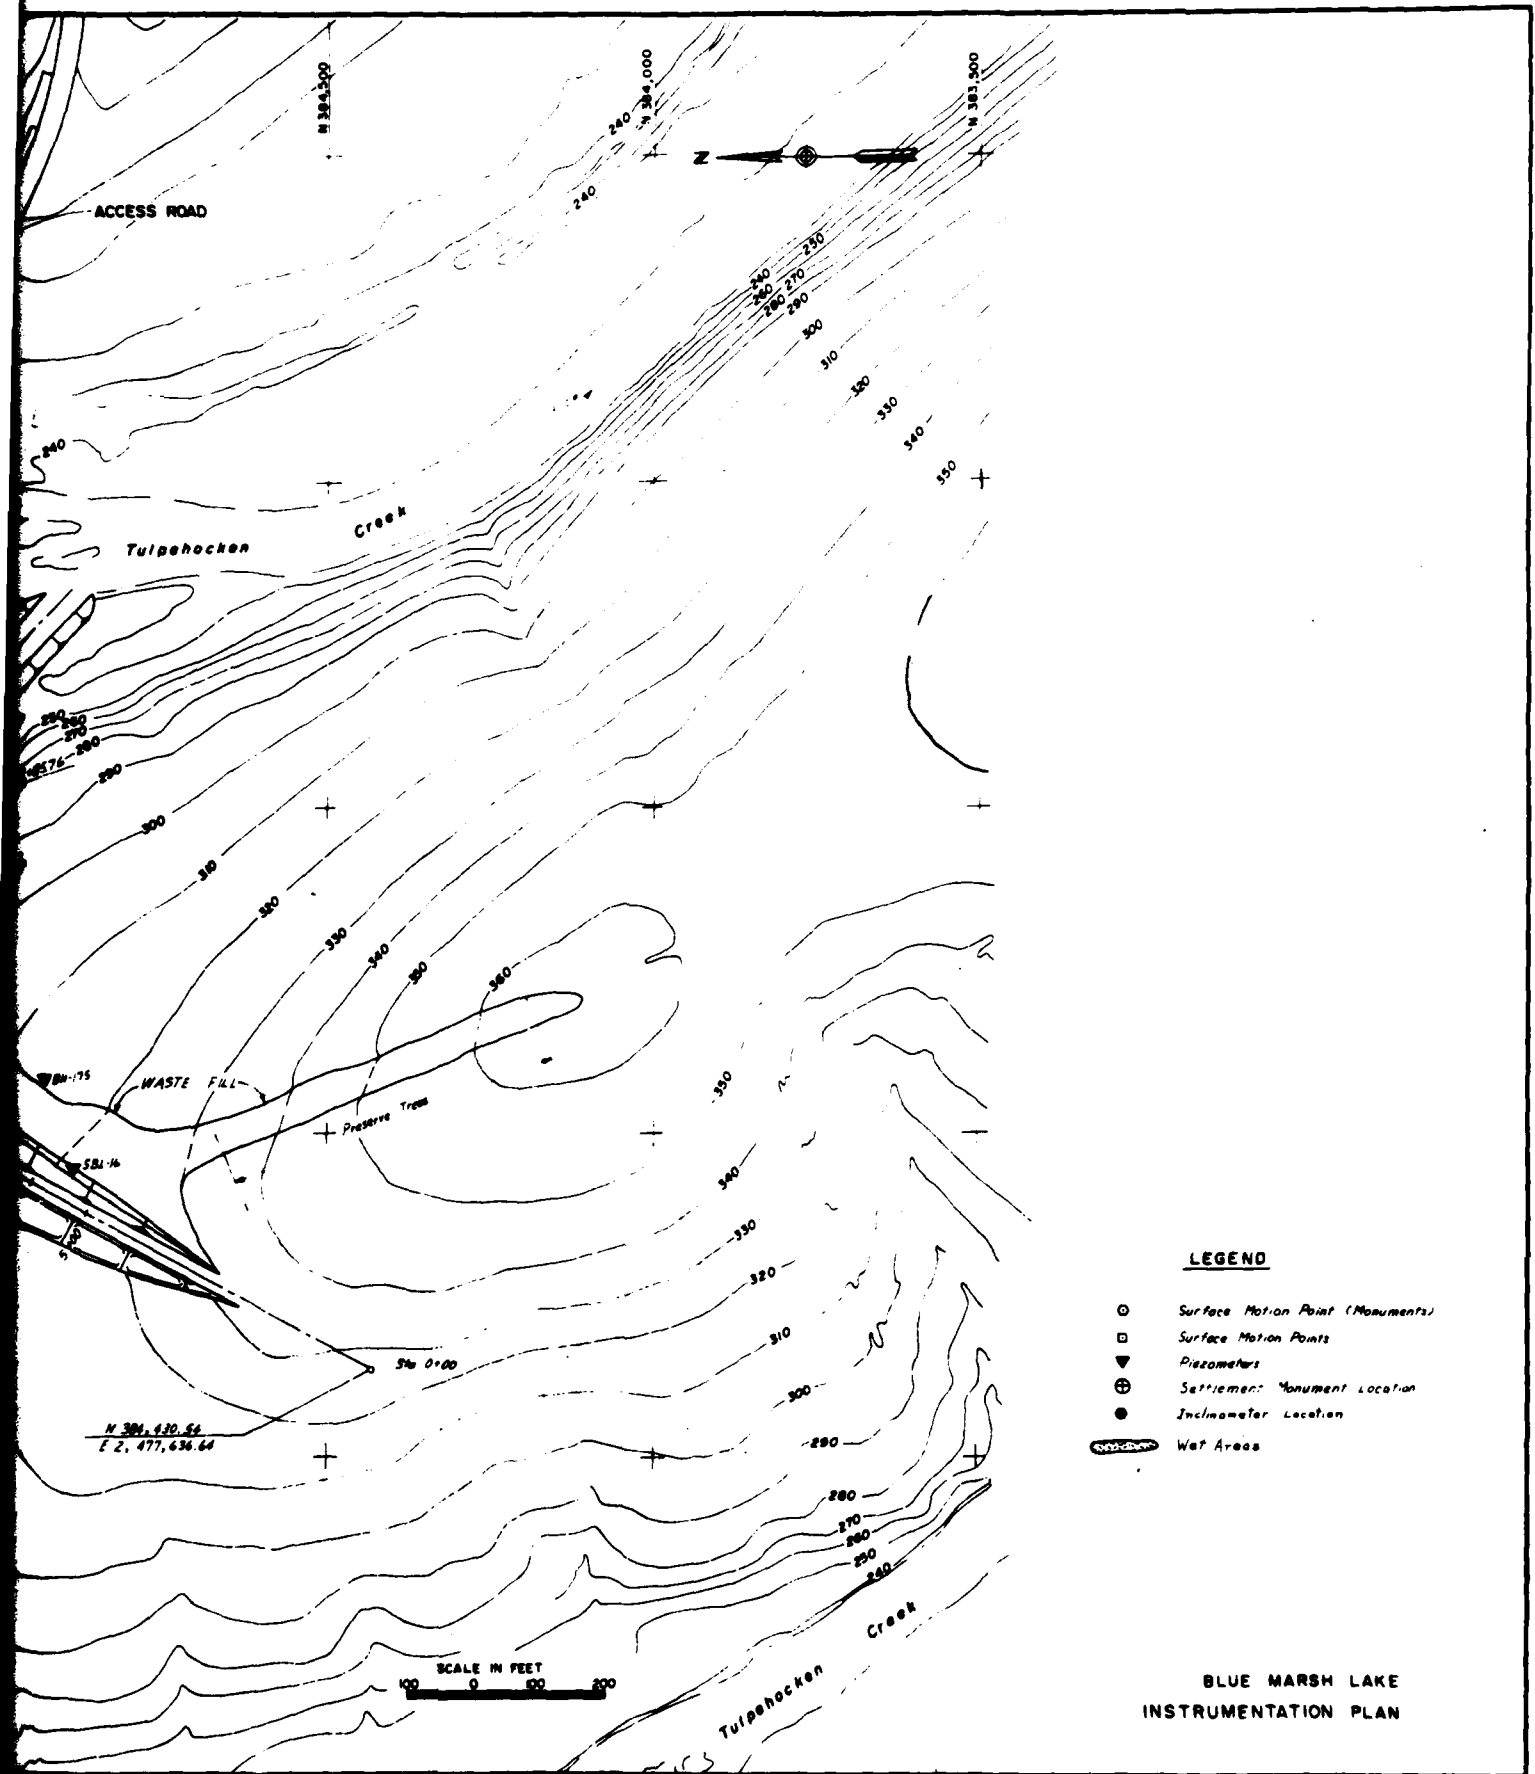
BLUE MARSH LAKE  
INSTRUMENTATION PLAN

b. The seepage area noted during the first Periodic Inspection in the foundation at the downstream toe of the slope at Sta 8+00 (near piezometer SBL-14) was noted again during this periodic inspection. This wet area has shown little change in character, location or extent since the first periodic inspection which was performed prior to the filling of the reservoir. Several wet areas were also noted during these same two inspections along the upstream toe of slope on the right abutment between STA. 8+00 and 10+00. These upstream areas seem to be due to the ponding of surface water rather than seepage. The location and approximate extent of these wet areas are shown on Plate No. 1 (Instrumentation Plan). No action required.

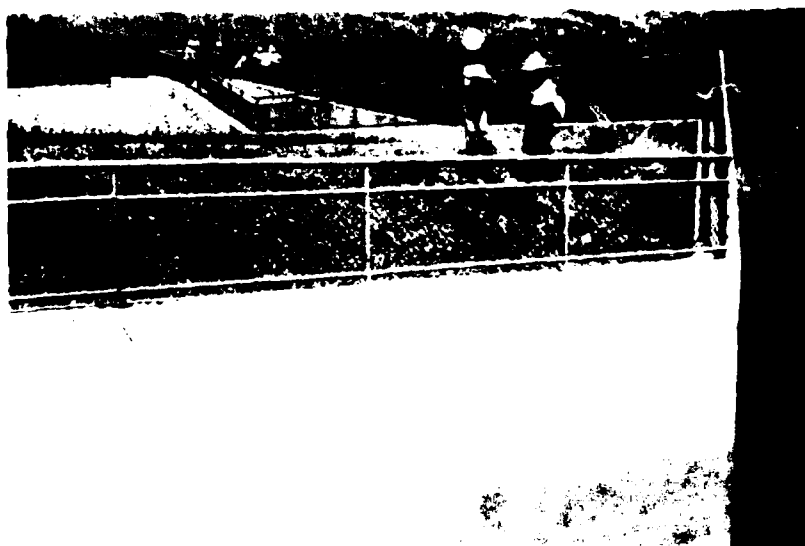
5. Stilling Basin and Outlet Channel.	Cracks in concrete at junction of wing walls and end walls. Noted in Periodic Inspections 1 and 2.	None required.
	Hand rail posts on both chute walls, forced up resulting in bent hand rails and spalling of concrete around base of posts. Noted in Periodic Inspection No. 2.	None required.
	Slight erosion of the left bank of the outlet channel beyond the riprap and on the lower portion of the service parking area slope. Noted in Periodic Inspection No. 2.	None required.

Photo No. 1. Cracks in wingwall-right side of stilling basin

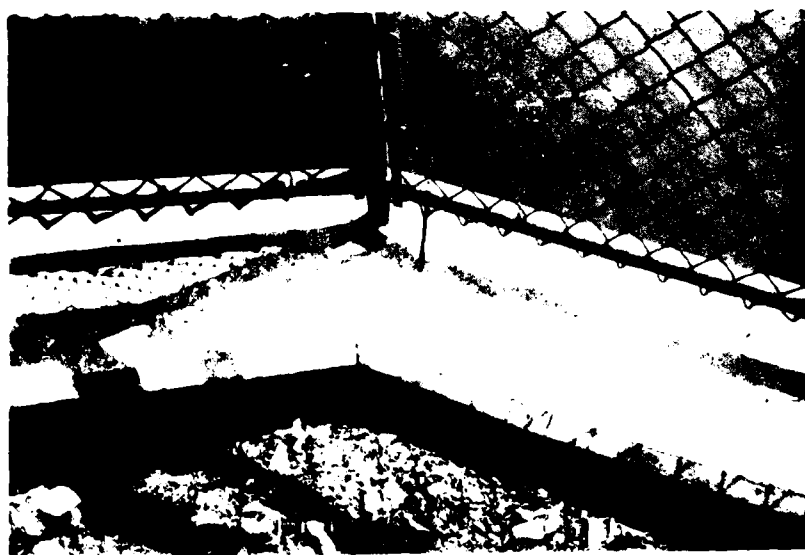
Photo No. 2. Crack at wingwall/stilling basin wall intersection -  
right side

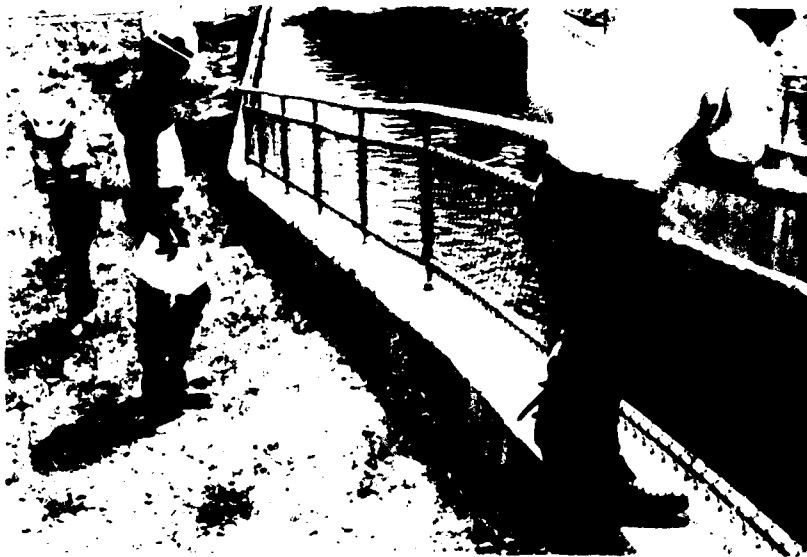
Photo No. 5. Displacement of stilling basin posts and handrails  
- left side.

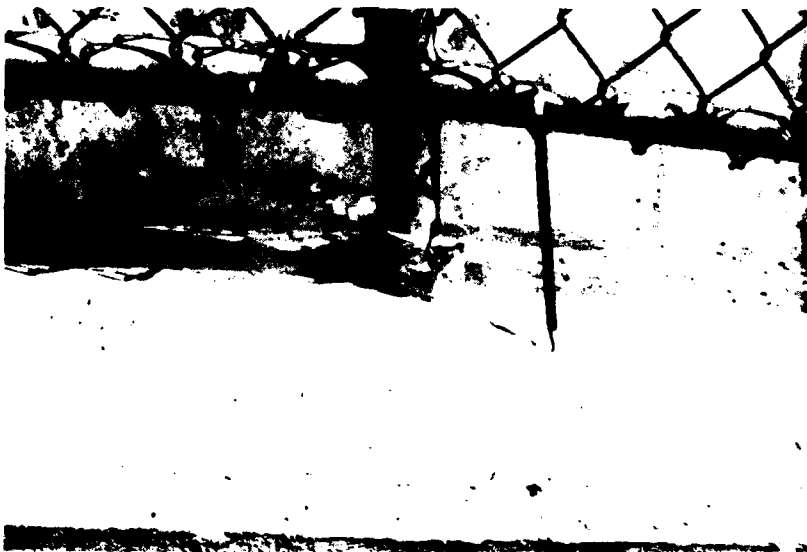
Photo No. 6. Close up at base of displaced post-right side
